Manhole Inspection Summary

Manhole # S49II_039MH

Inspection ☐ Is Incomplete Rating: **3) Fair**

Insp Date: **5/14/08 9:00 AM**

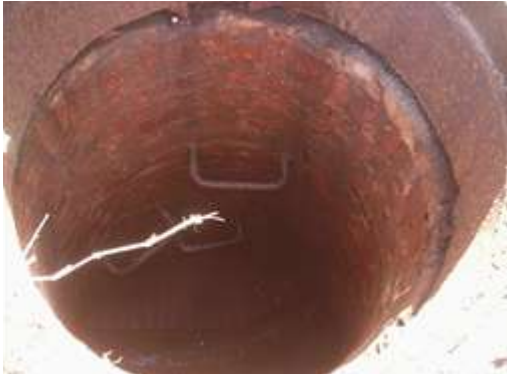
Defect 2

Frame Offset: **1** (in.) Condition: ☒ Sound ☐ Cracked ☐ Leaks

frame leaks

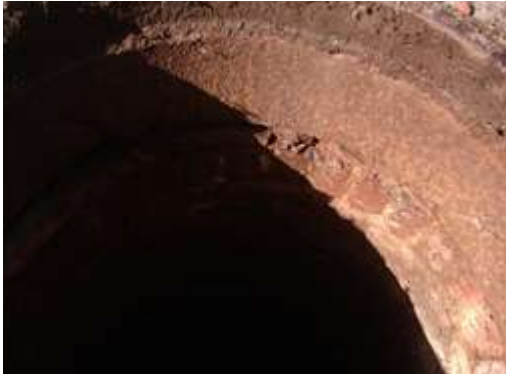
Defect 1

Infiltration: ☐ None ☒ **Joint** ☐ Cracks ☐ Mortar ☐ Roots ☐ Wall

Infiltration: ☐ None ☐ Joint ☐ Cracks ☐ Mortar ☐ Roots ☒ **Wall**

Infiltration

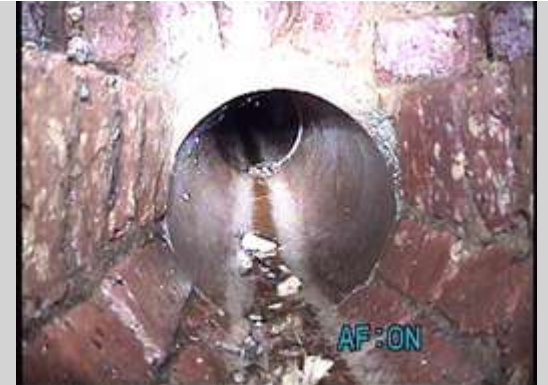
12 O'Clock Outflow

8 in. Circular Gravity Sewer
Pipe Out @ 12 O'Clock

Pipe Height: **8.4** (in.) Rod and Bar (Angled)
Pipe Material: **Clay** ☐ Pipe Lined
Invert Depth: **9.35** (ft.) Flow Characteristics: **Fast**
Deposits: ☒ None ☐ Mud ☐ Sludge ☐ Debris ☐ Grease
Silt Depth: (in.) Deposits Extent:
Infiltration: **None** Pipe Seal Cond: **Sound**

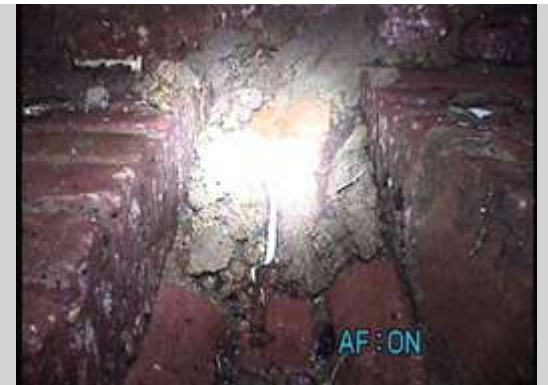
5 O'Clock Inflow

Pipe In @ 5 O'Clock

Pipe Height: (in.) Rod and Bar (Angled)
Pipe Material: **Clay** ☐ Pipe Lined
Invert Depth: (ft.) Flow Characteristics: **None**
Deposits: ☒ None ☐ Mud ☐ Sludge ☐ Debris ☐ Grease
Silt Depth: (in.) Deposits Extent:
Infiltration: **None** Pipe Seal Cond: **Sound**

Connects To: **Stub connection / abandoned**

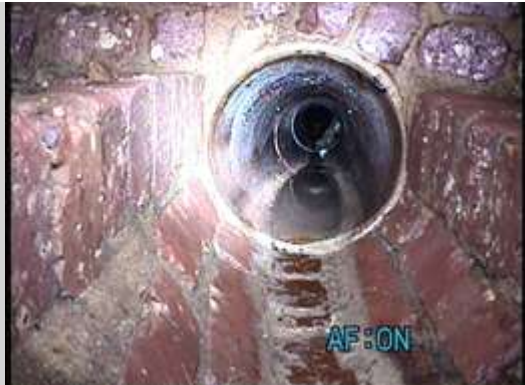
7 O'Clock Inflow

Pipe In @ 7 O'Clock

Pipe Height: **8.4** (in.) Rod and Bar (Angled)

Invert Depth: **8.60** (ft.) Flow Characteristics: **Fast**

Infiltration: **None** Pipe Seal Cond: **Sound**
